**PHOTOGRAPHIC INTERPRETATION COMPENDIUM**

**SOUTHEAST ASIA ACTIVITY REPORT**

**THANH HOA/VINH  
RAIL SEGMENT**

NPIC/R-68/68

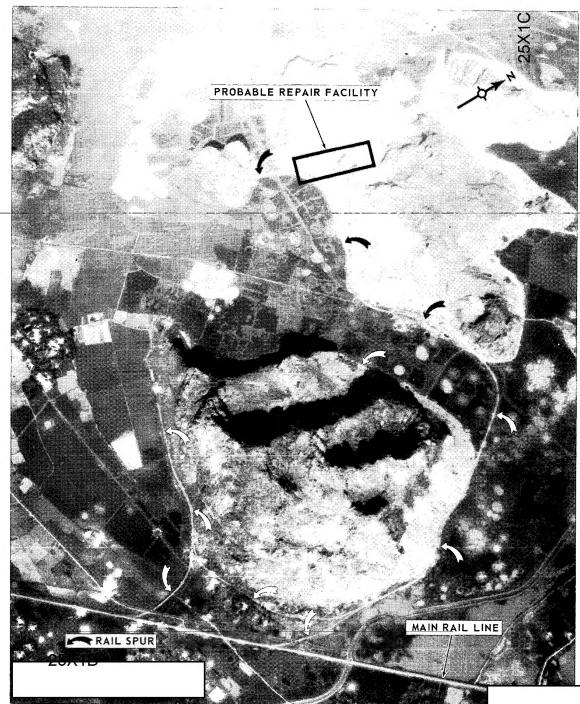
FIGURE 1. PROBABLE LOCOMOTIVE/CAR REPAIR FACILITY AND ASSOCIATED RAIL ACTIVITY,  
QUANG NAP AREA, NORTH VIETNAM

2. Quang Nap Probable Locomotive/Car Repair Facility and Associated Rail Activity, 19-47N 105-45E. The Facility was identified in [redacted] (SEA Activity Report Summary 42) in a karst area at WG782887 and consists of a small four-track holding yard, a probable repair building with two tracks entering the building, and 2 support buildings. The single track access spur joins the main line at WG790880. Other rail spurs in the area include a serviceable spur which terminates at WG786884, and a serviceable spur which terminates at WG786880 and is also part of an unserviceable turning wye (Figure 1).

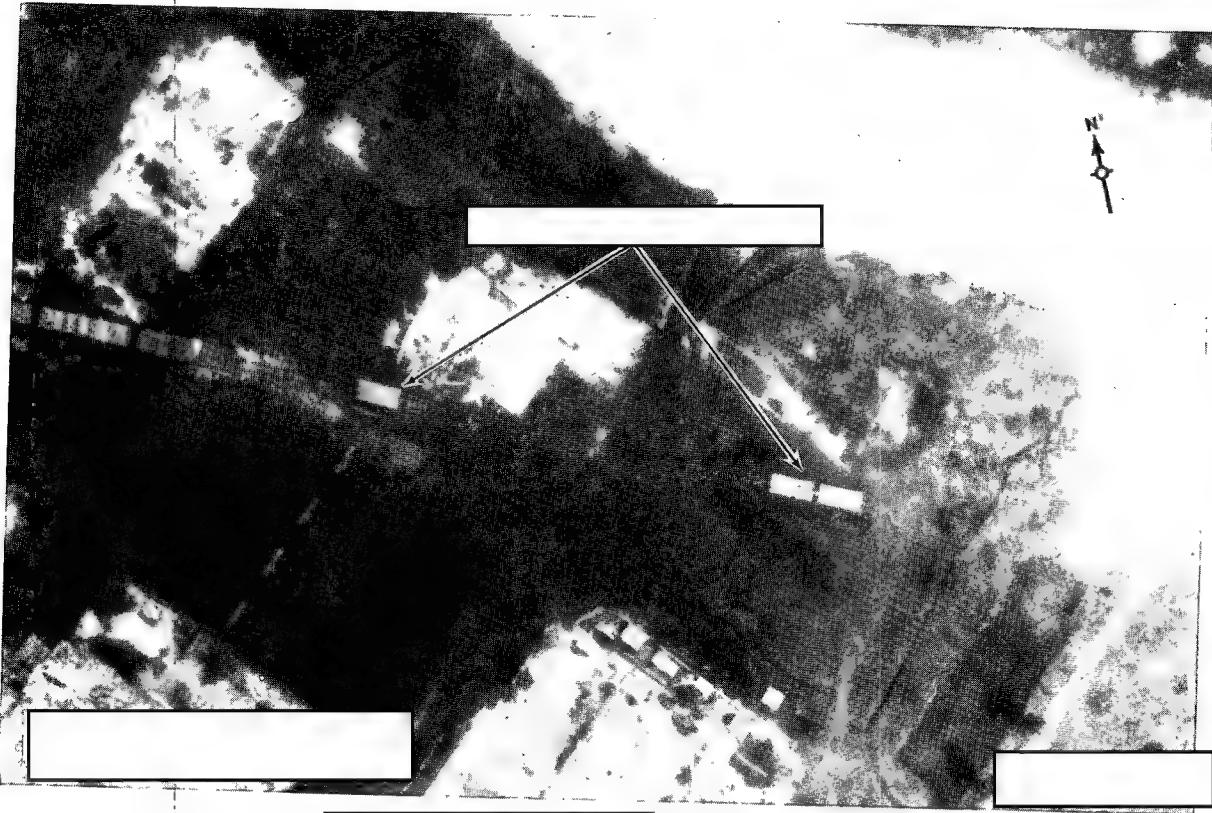
FIGURE 4.

YEN THAI, NORTH VIETNAM

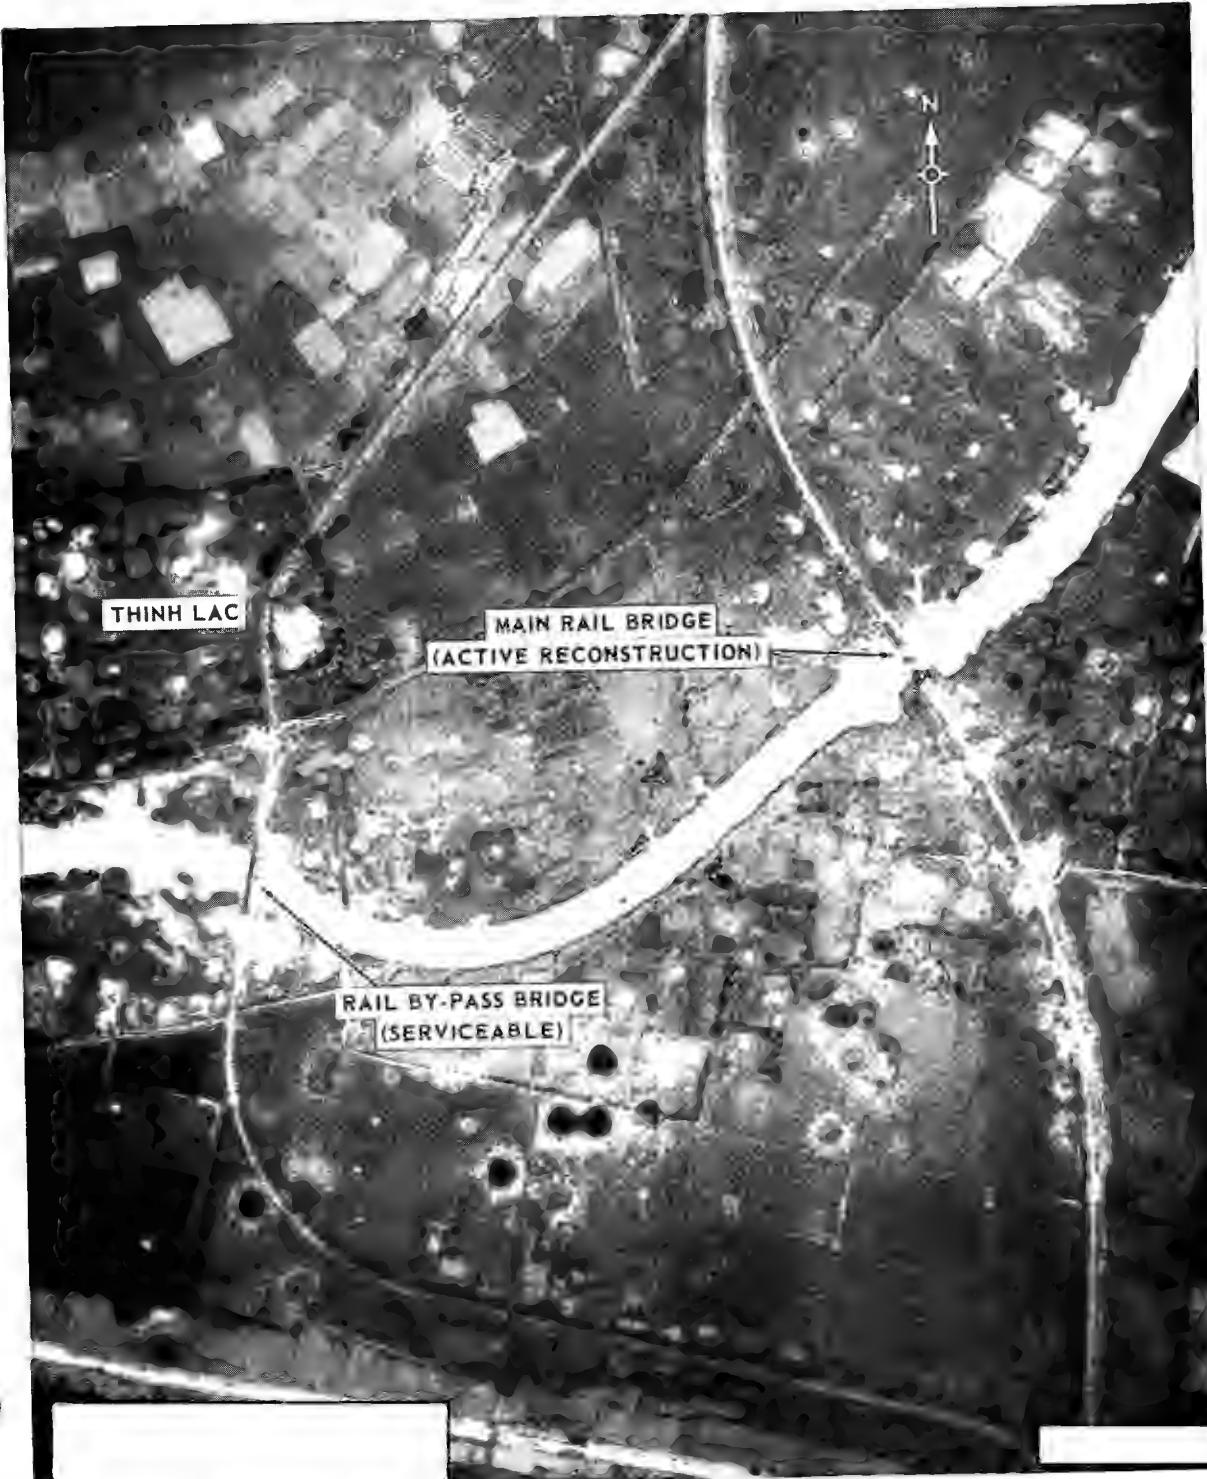
FIGURE 5. RAILROAD RIVER CROSSINGS, THINH LAC, NORTH VIETNAM

11. Nhan Nhuong Rail Bridge, 19-41N 105-42E (WG742767). Serviceable single-span rail bridge over a drainage ditch.
12. Thinh Lac Multiple River Crossings, 19-40N 105-42E. The main five-span rail bridge at WG741747 is unserviceable but there is evidence of reconstruction. The rail by-pass bridge at WG736746 is serviceable (Figure 5).

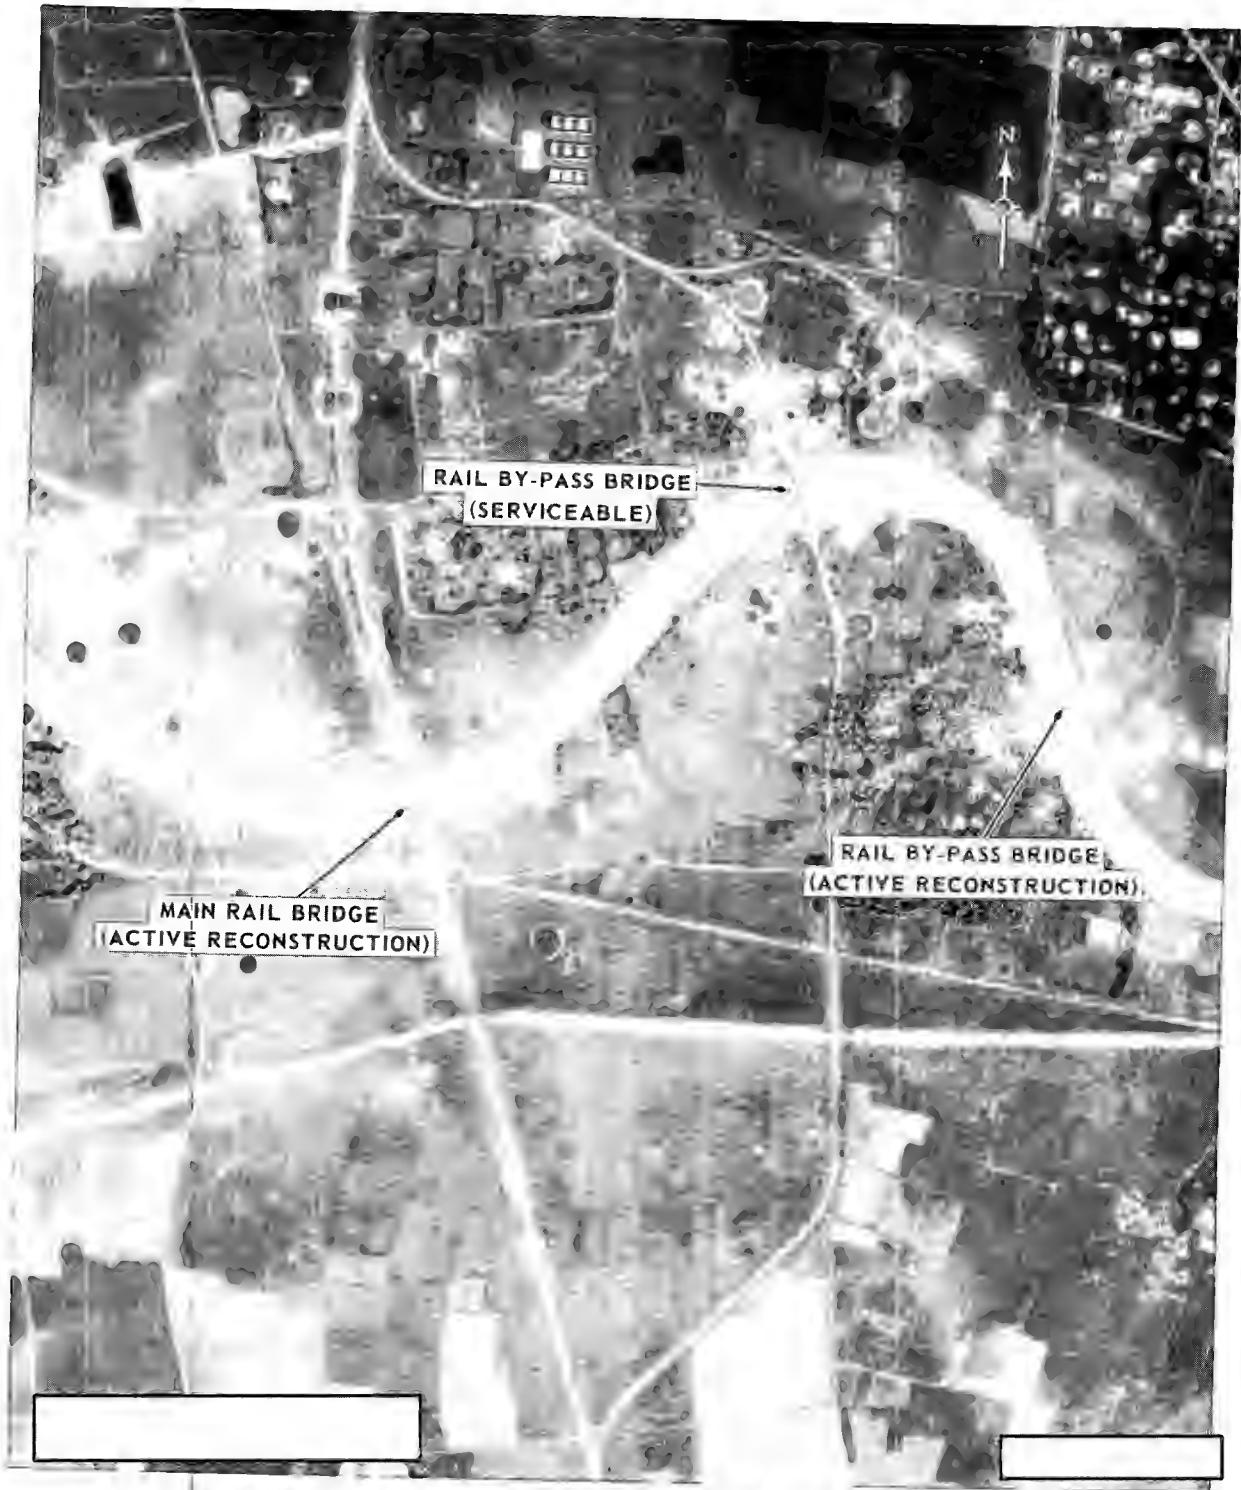
FIGURE 6. RAILROAD RIVER CROSSING, TRUONG QUANG TIEN AREA, NORTH VIETNAM

19. Truong Quang Tien Multiple River Crossing, 19-37N 105-42E. The main seven-span rail bridge at WG740696 is unserviceable but there is evidence of reconstruction; the seven-span rail by-pass bridge at WG744699 is serviceable; and the nine-span rail by-pass bridge at WG746697 is unserviceable but under reconstruction (Figure 6). Figure 7 shows the type of rolling stock normal to this segment of rail line. The train consists of 6 modified two-axle flat cars pulled by two lorries.

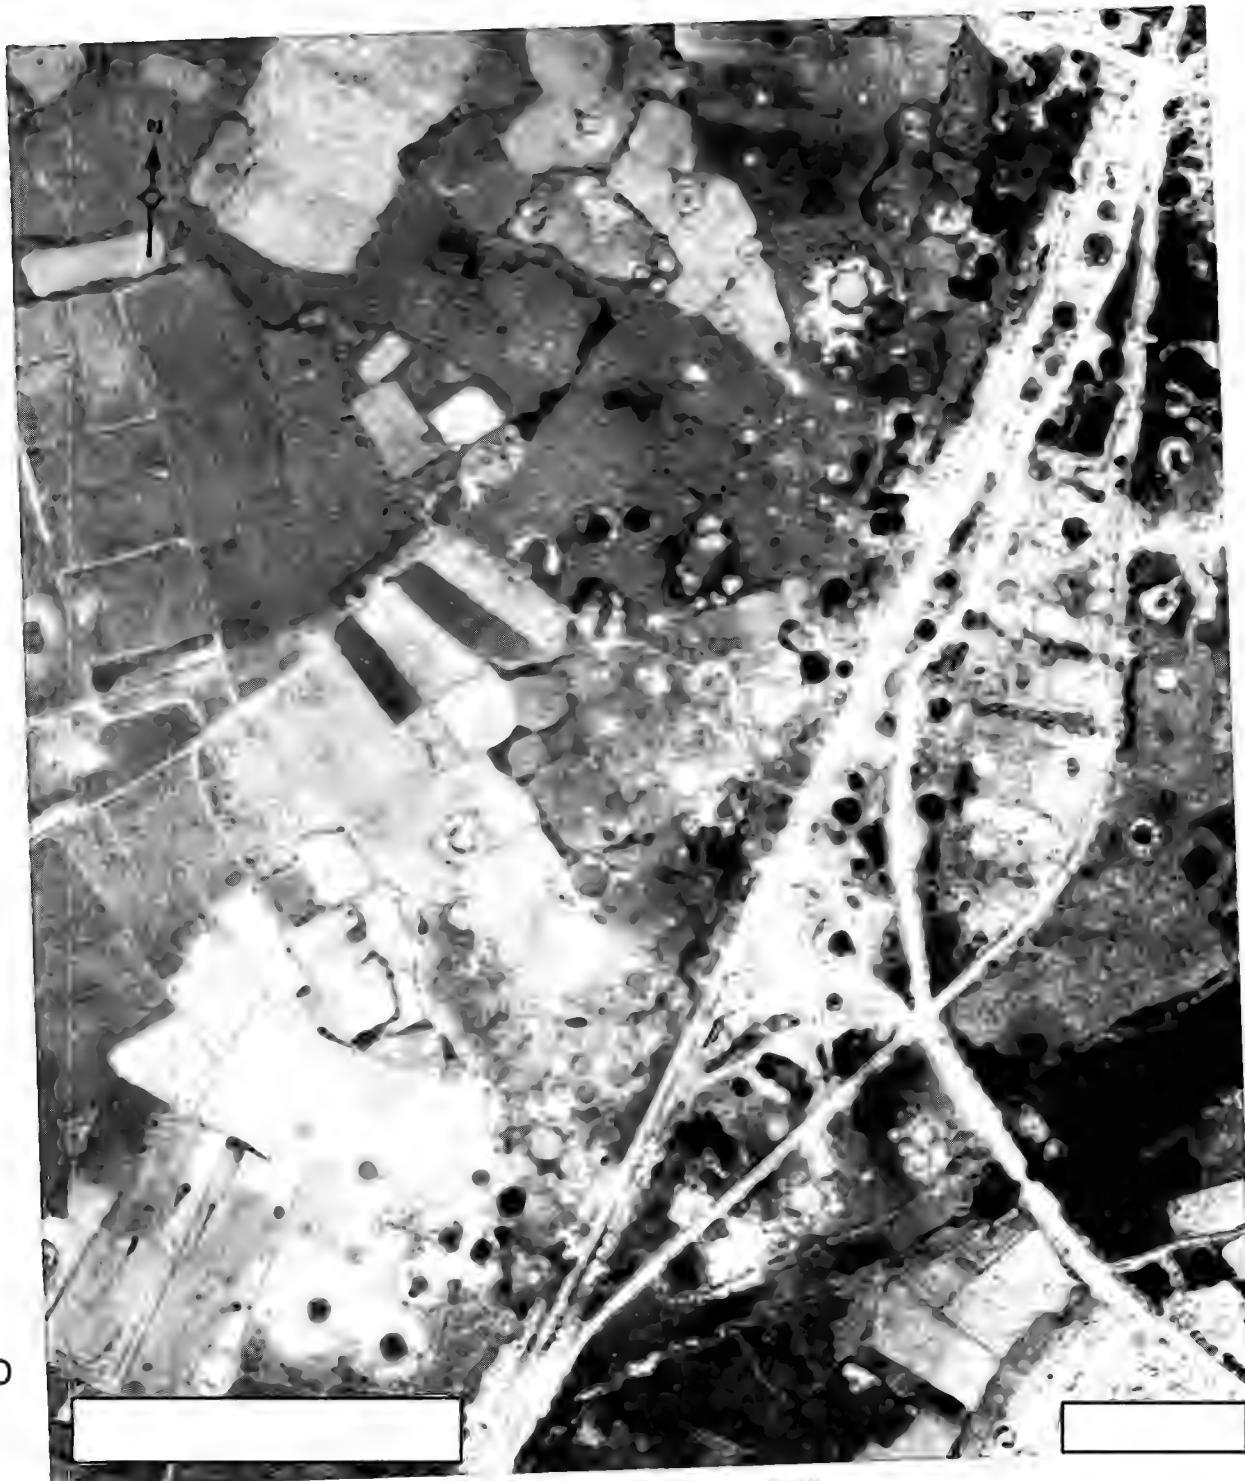
FIGURE 10. SON YEU RAIL YARD, NORTH VIETNAM

29. Son Yeu Rail Yard, 19-27N 105-46E (WG805514). Approximately 2,900 ft by 3 tracks wide with all facilities destroyed (Figure 10).

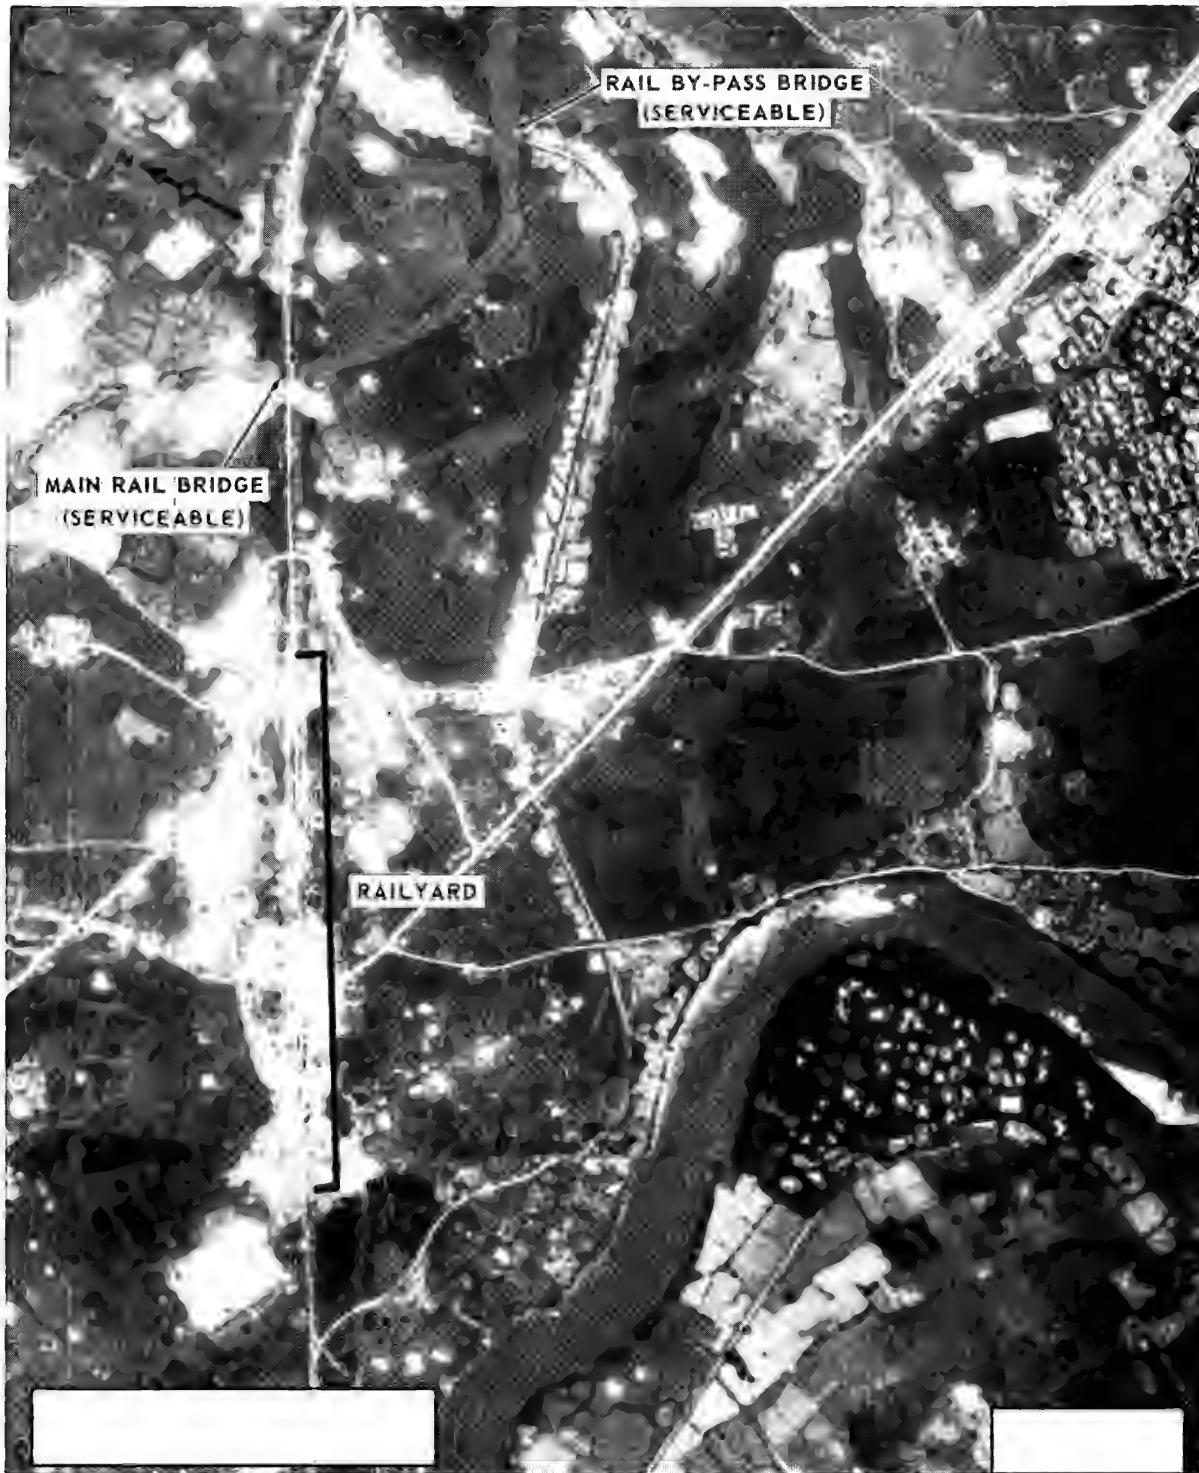
FIGURE 12. RAIL YARD AND STREAM CROSSINGS, QUI VINH, NORTH VIETNAM

43. Qui Vinh Multiple Stream Crossing NE, 19-16N 105-42E. The main two-span rail bridge at WG740305 is serviceable. The rail by-pass bridge (probably seven-spans) at WG744304 is serviceable. The rail by-pass also circumvents the Qui Vinh Rail Yard (Figure 12).

44. Qui Vinh Rail Yard, 19-15N 105-42E (WG736302). Track is approximately 1,800 ft by 3 tracks wide (one track destroyed/dismantled). Two rail by-passes circumvent the yard (Figure 12).

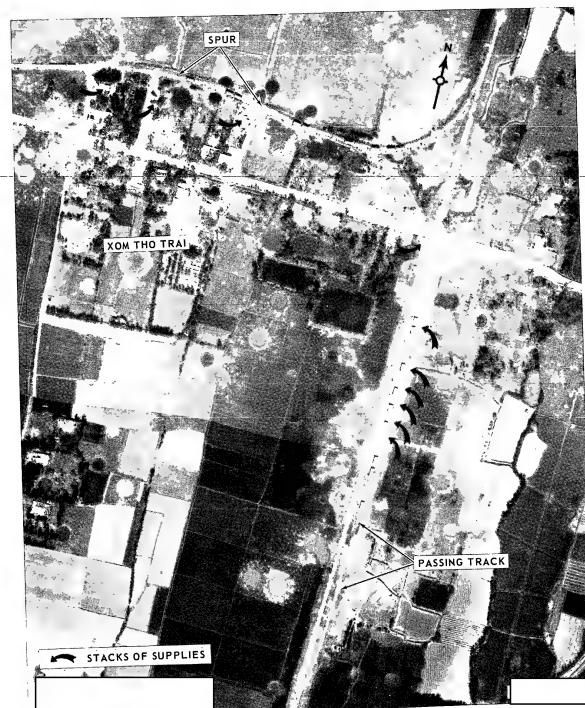
FIGURE 16. TRANSSHIPMENT POINT, XOM THO TRAI AREA, NORTH VIETNAM  
25X1D

59. Xom Tho Trai Passing Track and Transshipment Point, 19-00N 105-34E (WG610016). Passing track is approximately 1,200 ft long. An 1,800 ft rail spur extends west from the main rail line. At least 16 supply storage points, some canvas covered, are observed adjacent to the passing track and the spur. Several short access roads extends from an unnumbered road to the spur. A short abandoned rail segment extend from the rail spur to the main line, and if this segment were serviceable, it would provide a turning wye (Figure 16).

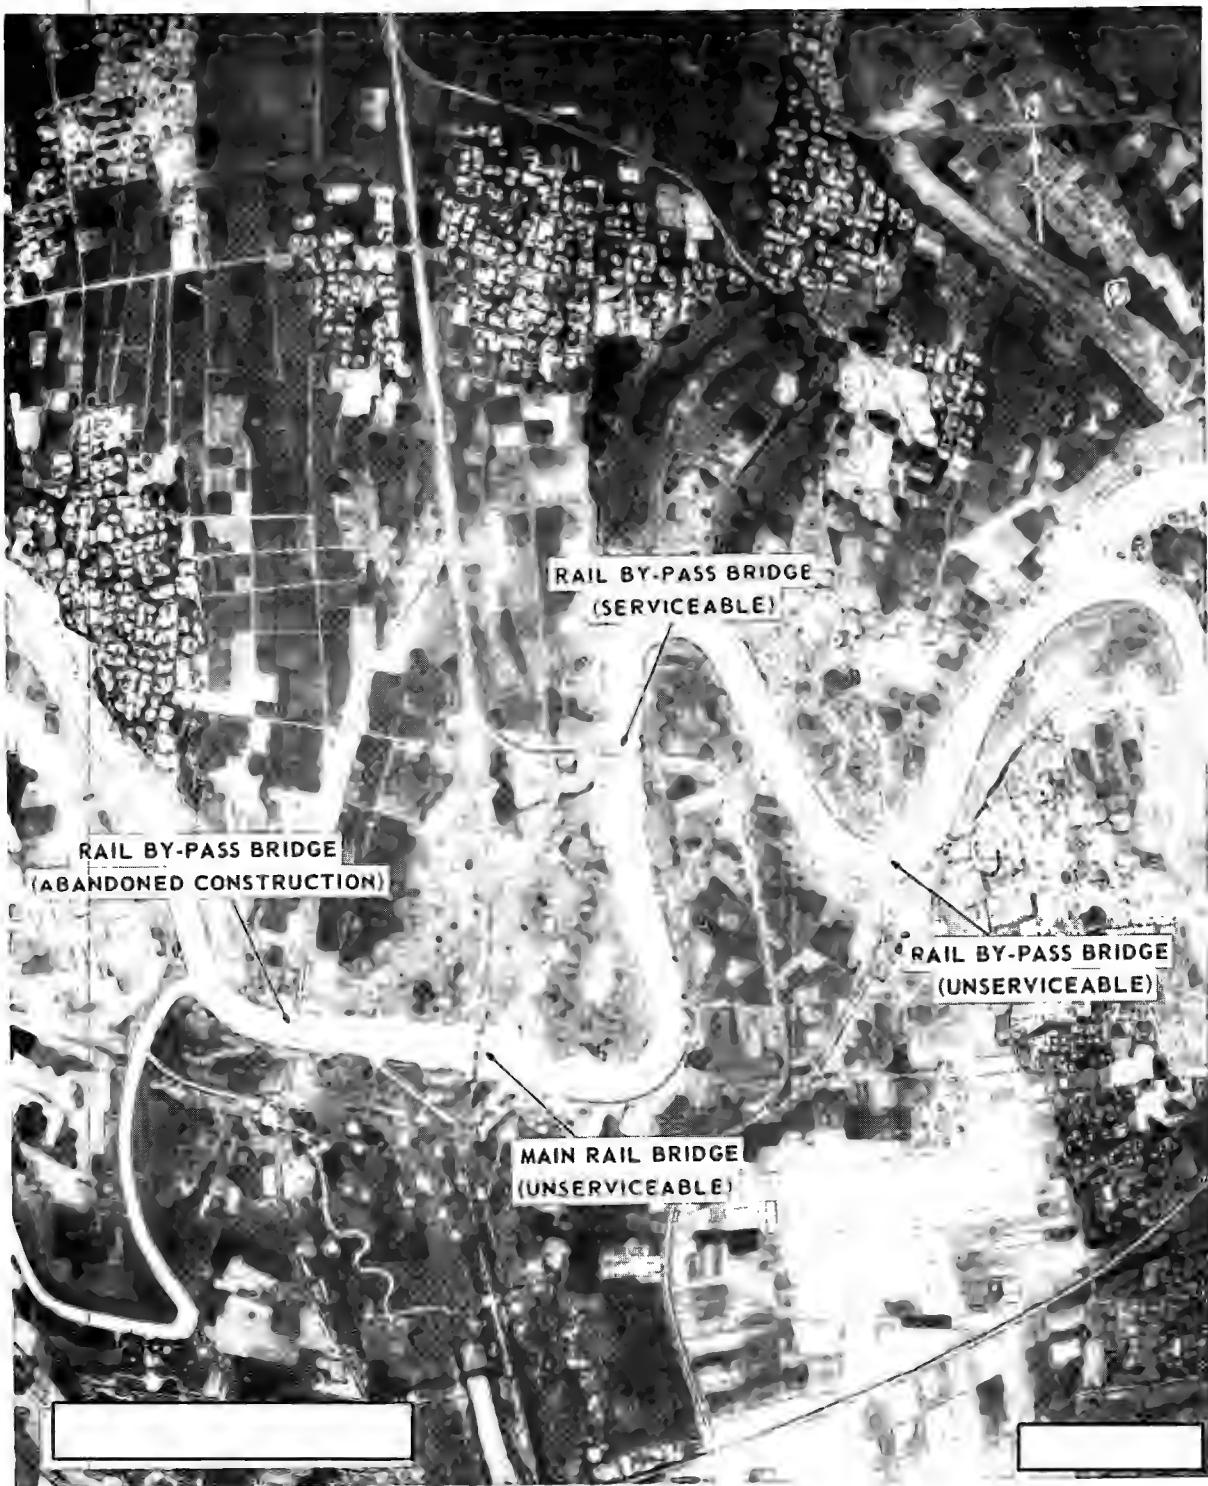
FIGURE 18. RAILROAD RIVER CROSSINGS, PHU DIEN CHAU, NORTH VIETNAM

62. Phu Dien Chau Multiple River Crossings, 18-58N 105-34E. The main three-span rail bridge at WF613978 has been destroyed but there is evidence of reconstruction. A six-span rail by-pass bridge at WF619980 is unserviceable with four spans missing; the seven-span rail by-pass bridge at WF615980 is serviceable. The construction on a nine-span rail by-pass bridge at WF610978 has apparently been abandoned (Figure 18).

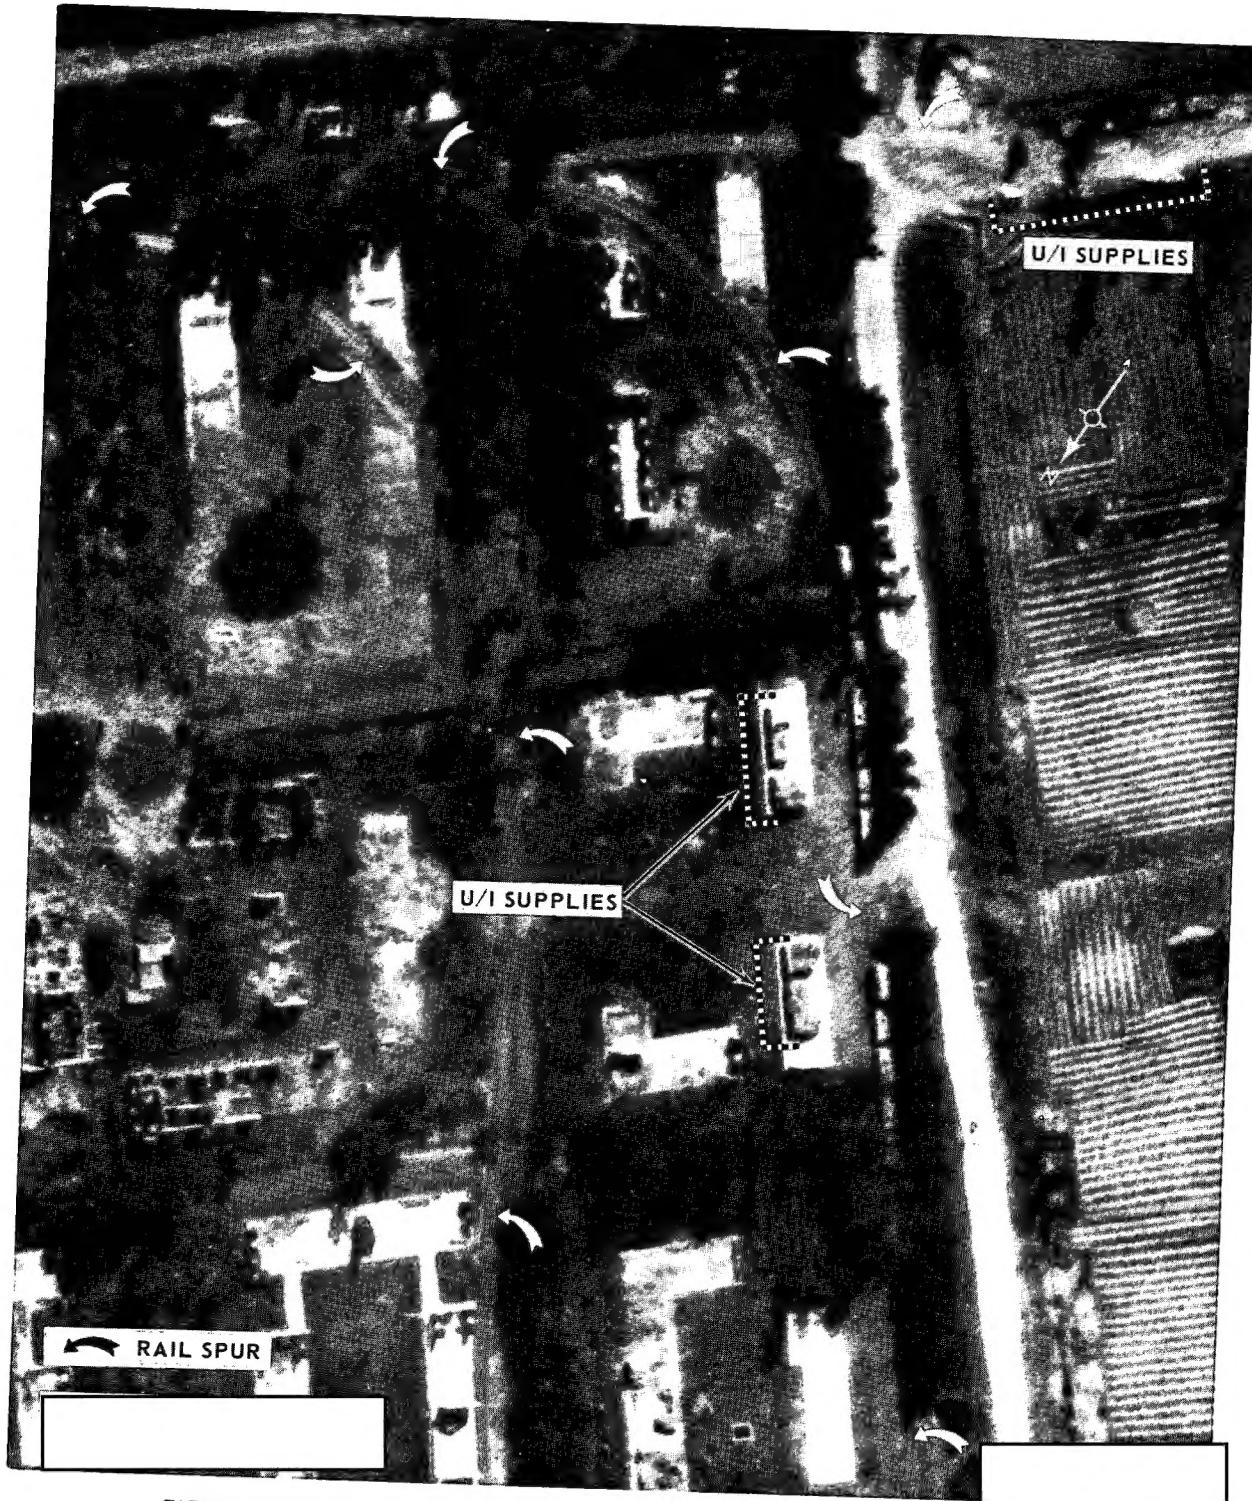
FIGURE 21. TRANSSHIPMENT/STORAGE AREA, VINH AREA, NORTH VIETNAM

72. Vinh Transshipment and Storage Area, 18-41N 105-39E (WF701657). Rail-served area at the site of a destroyed/dismantled army barracks consists of a loop service spur and one short spur. Stacks of unidentified supplies are on two of the remaining barracks foundations and also adjacent to the short spur. The area is served by a well used road network which connects to the Vinh road-to-water transshipment area at WF708633 (Figure 21).
